# melett

## OVERSPEEDING

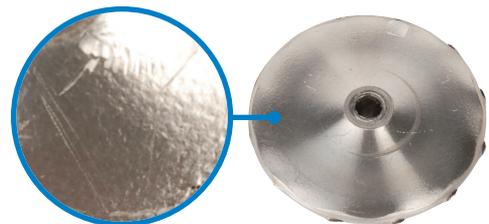
'Orange peel' effect on compressor wheels

- The turbocharger must always be left in the original state
- The turbocharger may only be installed in the specified vehicles
- Check there are no restrictions or leaks in the air intake pipe work
- Ensure the wastegate or VNT linkage is operating freely and is properly calibrated
- Check the electronic sensors and ECU are operating correctly
- Avoid remaps chipping or over-fuelling

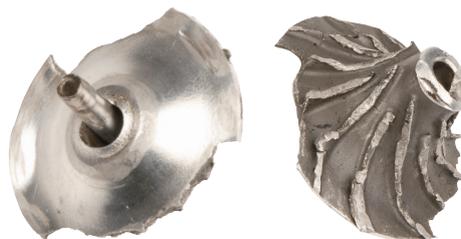
Complete component failure

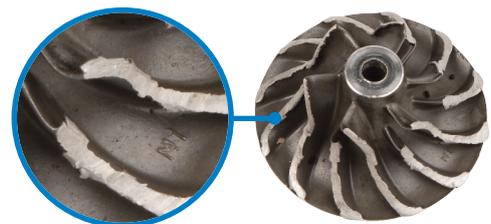
Compressor wheel rub
